## Exposure to Some Roofing Systems

## EXPOSURE OF SOME ROOFING SYSTEMS

B. F. Stafford

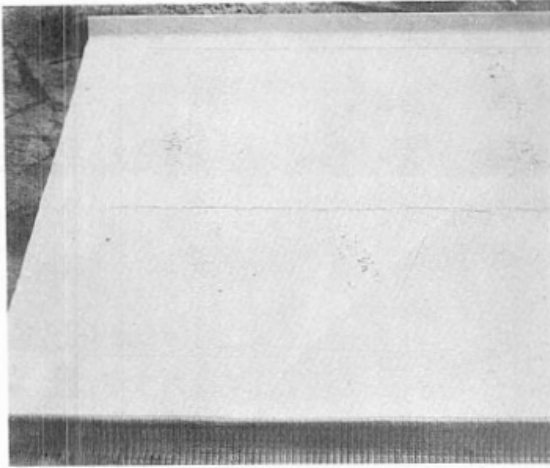
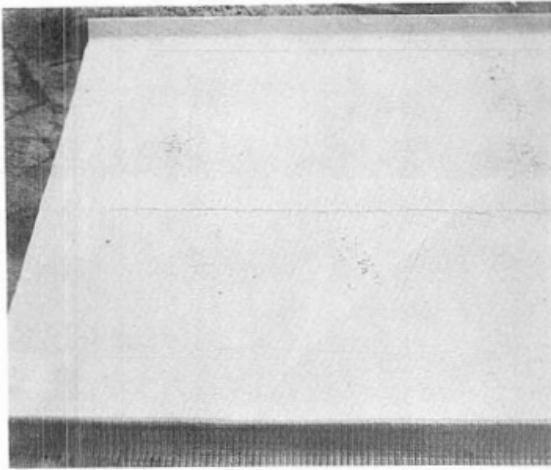
After 6 to 8 months exposure, small hairline cracks appeared over the entire surface about 2 in. apart. This random surface cracking

was very pronounced after 2 years and there was slight damage along the front edge. After 5 year's exposure, this effect had increased so that the distance between each hairline crack was reduced from  $\frac{1}{2}$  in. to  $\frac{1}{4}$  in.; this cracking did not, however, appear to affect the polyisobutylene sheet. Some small portions of the topcoat were beginning to peel and the adhesive at the centre overlap had failed for a distance of approximately 10 in. to a width of  $\frac{1}{4}$  in. Some blistering along the cant strip, and some slight chalking was observed, but there appeared to be only slight dirt retention.

ROOF NO. 1 - 5 years exposure:  
severe hairline cracking.

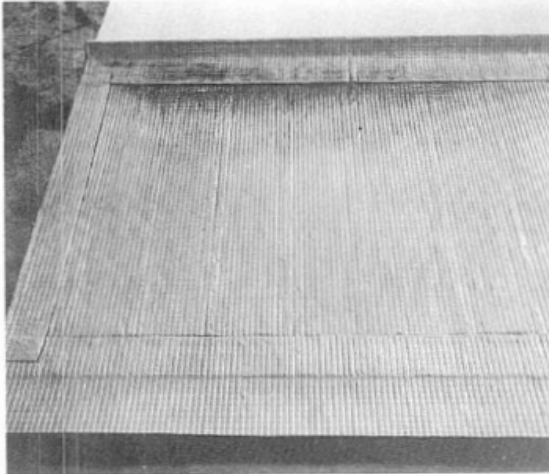
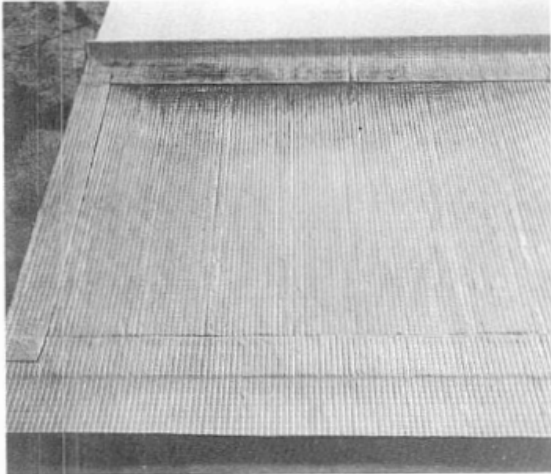
Slight dulling of the aluminum-foil surface had taken place by the end of the first 12 months of exposure. After 2 years, the glass reinforcement at the lap was beginning to show; 3 months later there was a slight loss of bond in two locations on the lap joints, 4 ft apart. The final observation after 5 years of exposure showed some loss of adhesion  $\frac{1}{2}$  in. inward on the overlap section covering the cant strip, in addition to 3 large ridges running perpendicular to the length of the deck. There were also 8 ridges 1-in. wide running across the width. Surface dulling was moderate and dirt retention moderately high in an area where water ponding took place.

ROOF NO. 2 - 5 years exposure:  
slight dulling and some ridging.

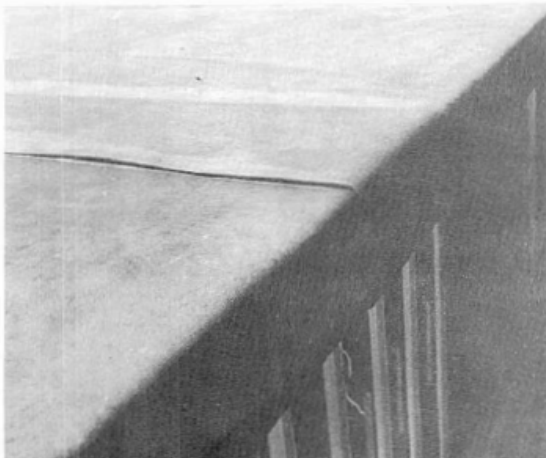
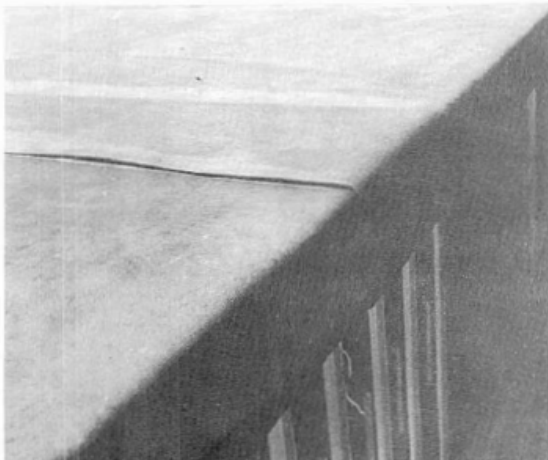
After 10 months, the centre-lap joint began to lift slightly. This loss of bond was more noticeable after 2 years when the lap had lifted approximately  $\frac{1}{8}$  in. along the length of the lap. By then, there was also a lightening of colour and a small crack at the front of the cant. After 5 years, the loss of bond along the lap joint had increased to a maximum depth of 1 in., chalking was of medium intensity, water staining along the low edge was severe, two nails from the deck had lifted but had not penetrated the butyl sheet, and the overlap at one of the corners of the cant strip had lost its adhesion.

ROOF NO. 3 - 5 years exposure:  
colour change, chalking and  
adhesive failure.
