Exposition de certaines toitures

Building Research Note

EXPOSURE OF SOME ROOFING SYSTEMS

B. F. Stafford

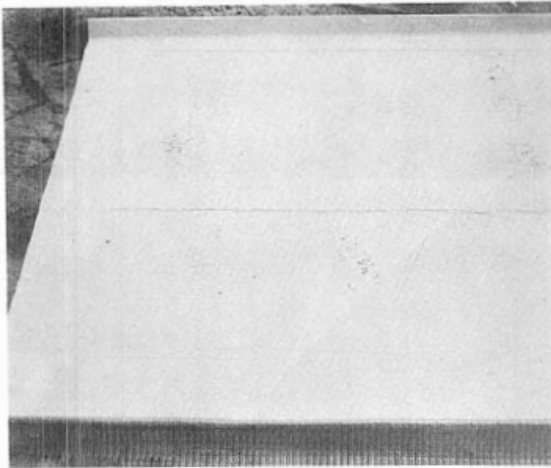
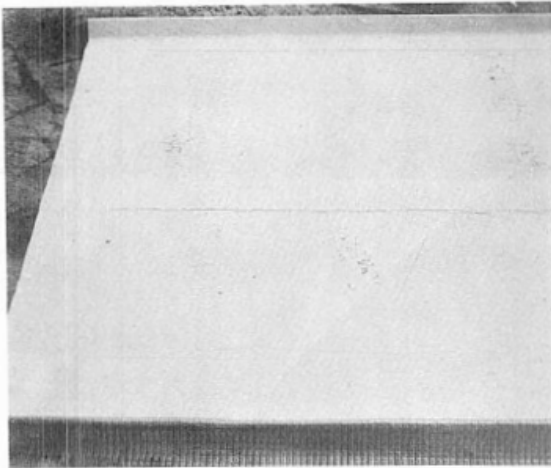
After 6 to 8 months exposure, small hairline cracks appeared over the entire surface about 2 in. apart. This random surface cracking

was very pronounced after 2 years and there was slight damage along the front edge. After 5 year's exposure, this effect had increased so that the distance between each hairline crack was reduced from $\frac{1}{2}$ in. to $\frac{1}{4}$ in.; this cracking did not, however, appear to affect the polyisobutylene sheet. Some small portions of the topcoat were beginning to peel and the adhesive at the centre overlap had failed for a distance of approximately 10 in. to a width of $\frac{1}{4}$ in. Some blistering along the cant strip, and some slight chalking was observed, but there appeared to be only slight dirt retention.

ROOF NO. 1 - 5 years exposure:
severe hairline cracking.

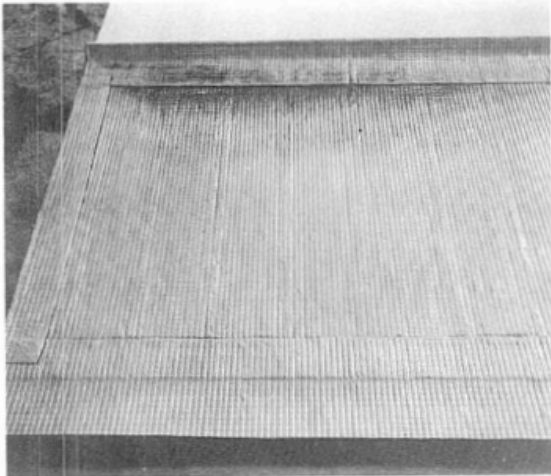
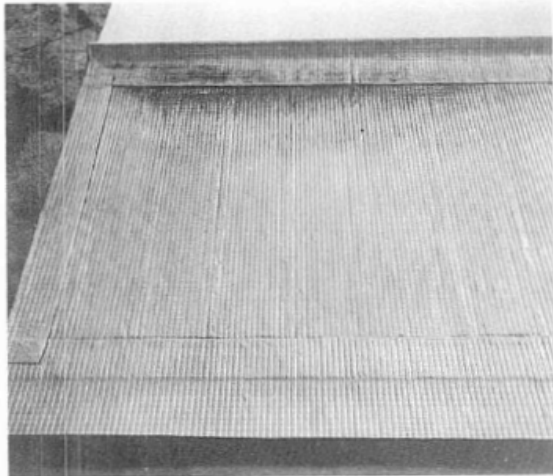
Slight dulling of the aluminum-foil surface had taken place by the end of the first 12 months of exposure. After 2 years, the glass reinforcement at the lap was beginning to show; 3 months later there was a slight loss of bond in two locations on the lap joints, 4 ft apart. The final observation after 5 years of exposure showed some loss of adhesion $\frac{1}{2}$ in. inward on the overlap section covering the cant strip, in addition to 3 large ridges running perpendicular to the length of the deck. There were also 8 ridges 1-in. wide running across the width. Surface dulling was moderate and dirt retention moderately high in an area where water ponding took place.

ROOF NO. 2 - 5 years exposure:
slight dulling and some ridging.

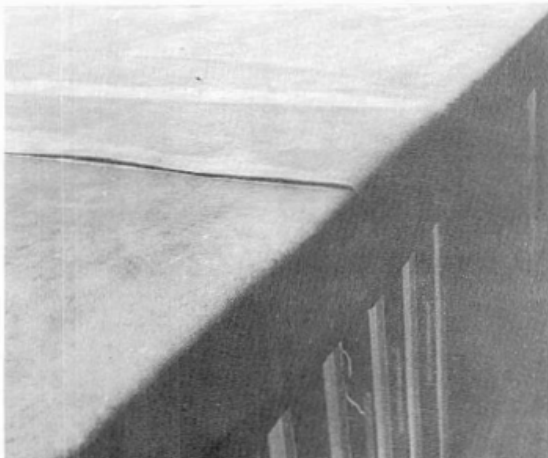
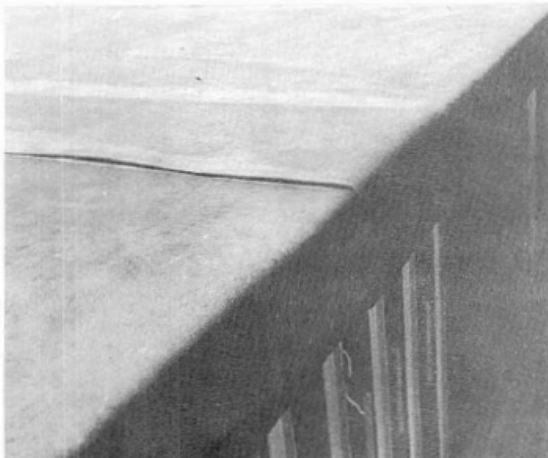
After 10 months, the centre-lap joint began to lift slightly. This loss of bond was more noticeable after 2 years when the lap had lifted approximately $\frac{1}{8}$ in. along the length of the lap. By then, there was also a lightening of colour and a small crack at the front of the cant. After 5 years, the loss of bond along the lap joint had increased to a maximum depth of 1 in., chalking was of medium intensity, water staining along the low edge was severe, two nails from the deck had lifted but had not penetrated the butyl sheet, and the overlap at one of the corners of the cant strip had lost its adhesion.

ROOF NO. 3 - 5 years exposure:
colour change, chalking and
adhesive failure.
